Office of the West Virginia Attorney General

Elk River Chemical Spill INCIDENT REPORT

January 8, 2015

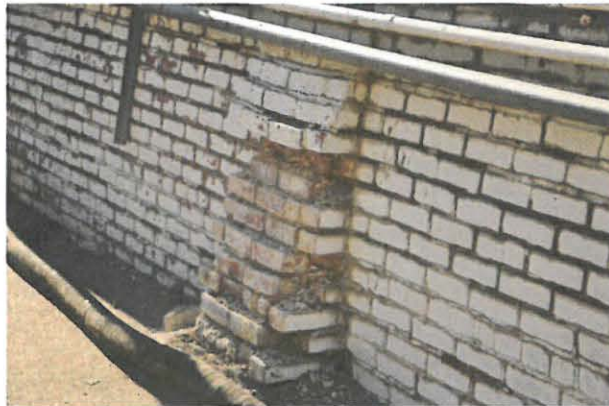
Containment wall facing Barlow Drive

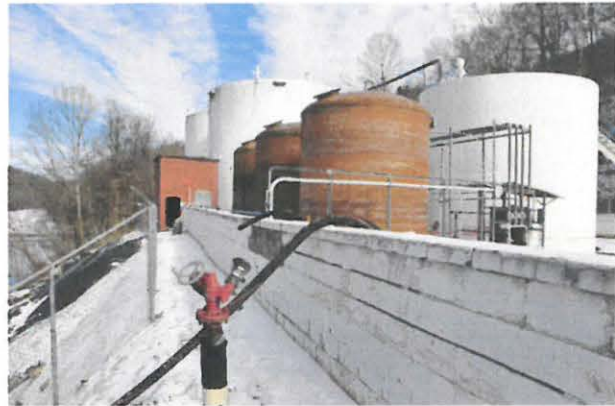
Containment wall facing Elk River

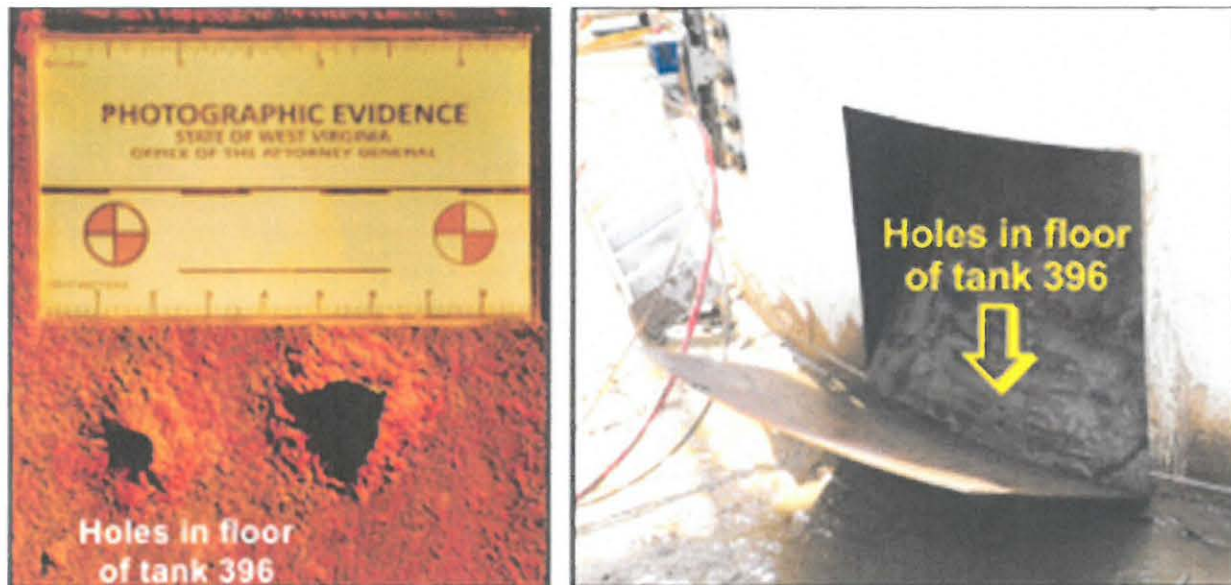
In particular, an inspection of tank 396 revealed that two holes existed on the floor. The first (larger) hole measured approximately 5/8" x 21/32", while the second (smaller) hole measured approximately 1/4" x 9/32". The holes in the bottom of the tank are positioned approximately 2 1/2 inches to 4 1/4 inches inside the tank wall.

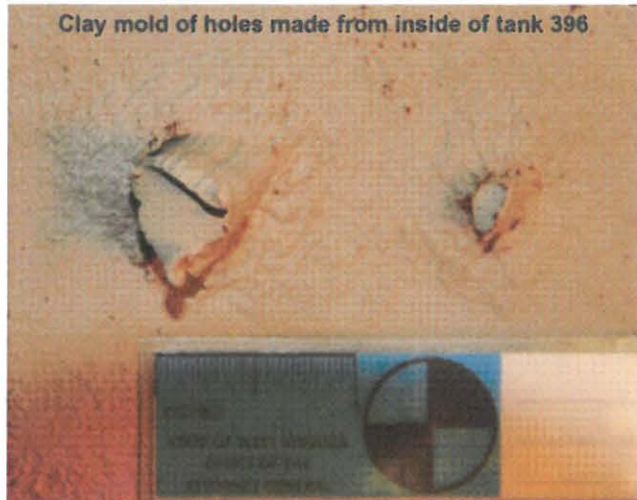
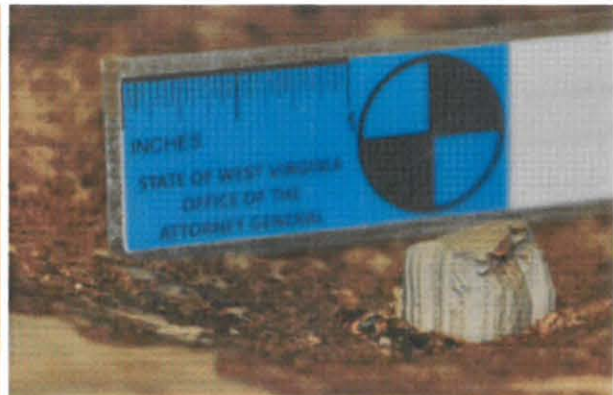
As part of its investigation, the WVAGO additionally obtained and produced clay moldings of the holes to document their respective size and shape.

Clay mold made of bottom of tank 396

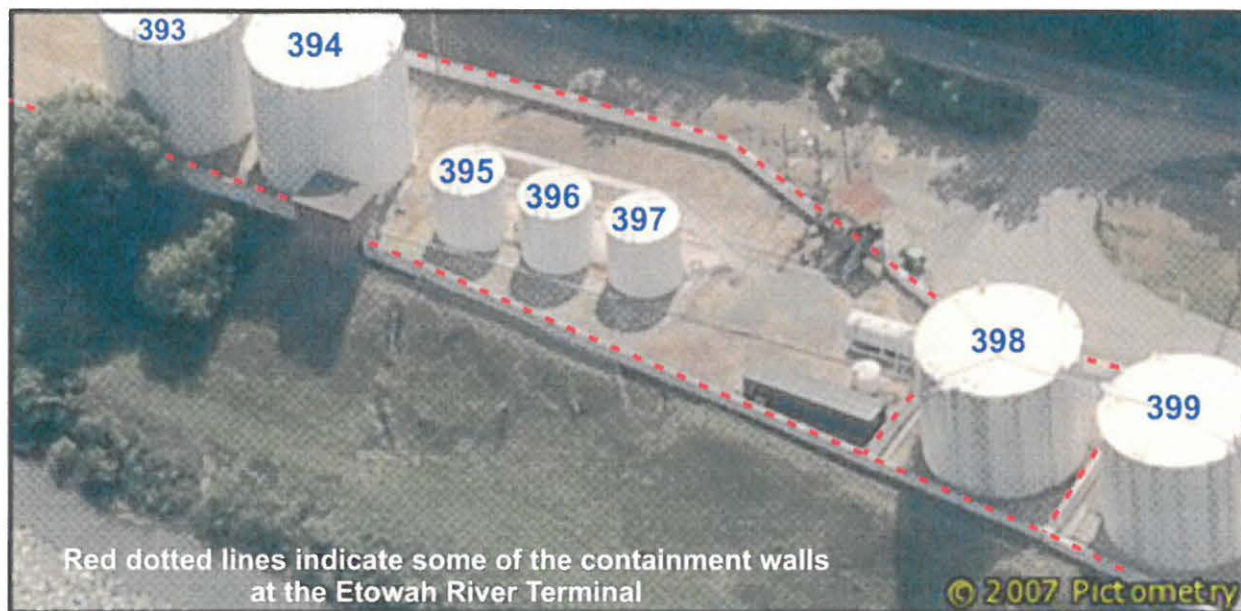
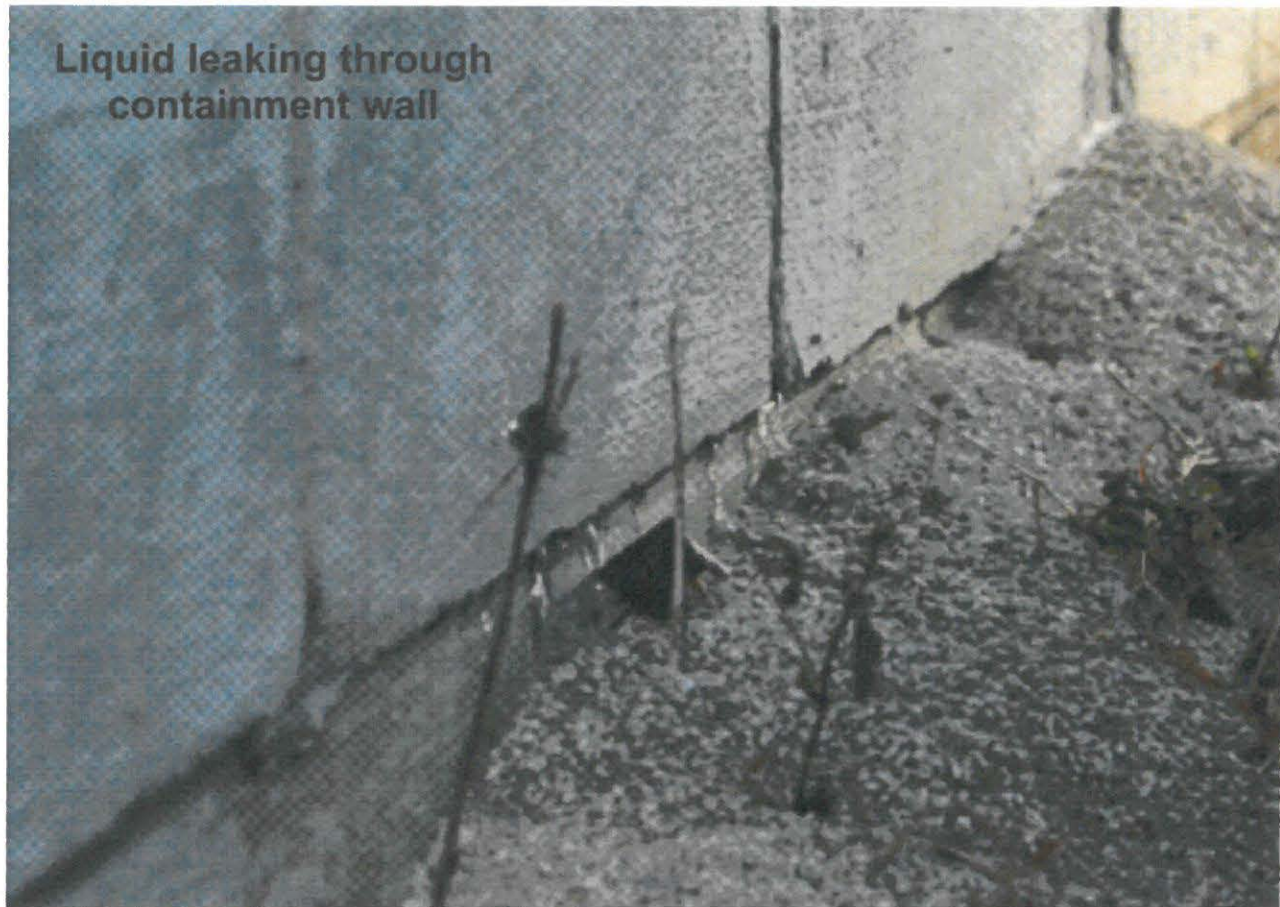
All ASTs were surrounded by a containment wall that extended the length of the property. This was to serve as a secondary containment system in case of a leak. The WVAGO investigation revealed that the containment wall failed and chemical product flowed both through and underneath the containment wall. In particular, the WVAGO was able to document frozen substances coming out of the wall several days after the event.

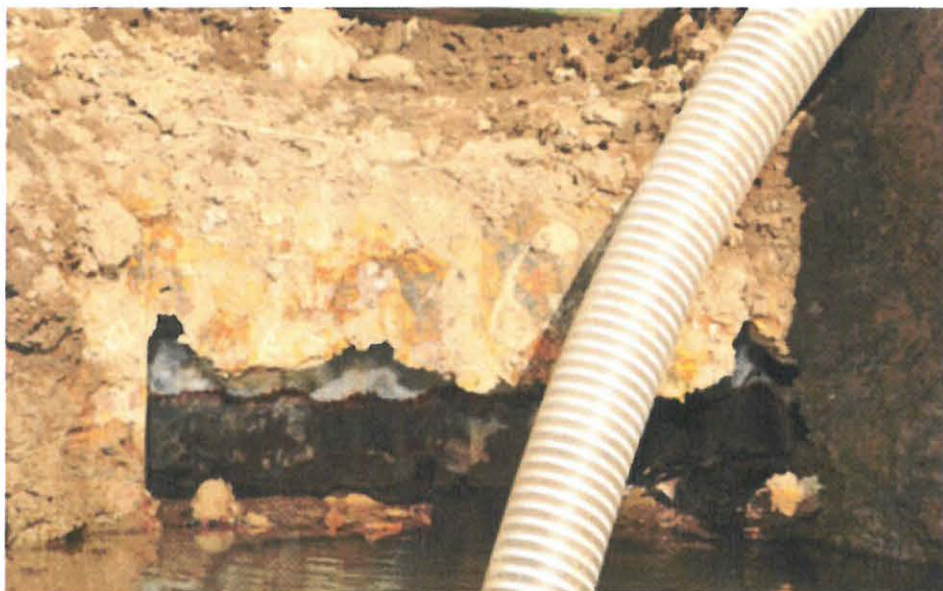
Second, a culvert running underneath the property became deteriorated and broken, thus facilitating the water flow into the Elk River. The WVAGO investigation indicates that the chemical product leaked into openings in the culvert and provided a more direct path into the Elk River.

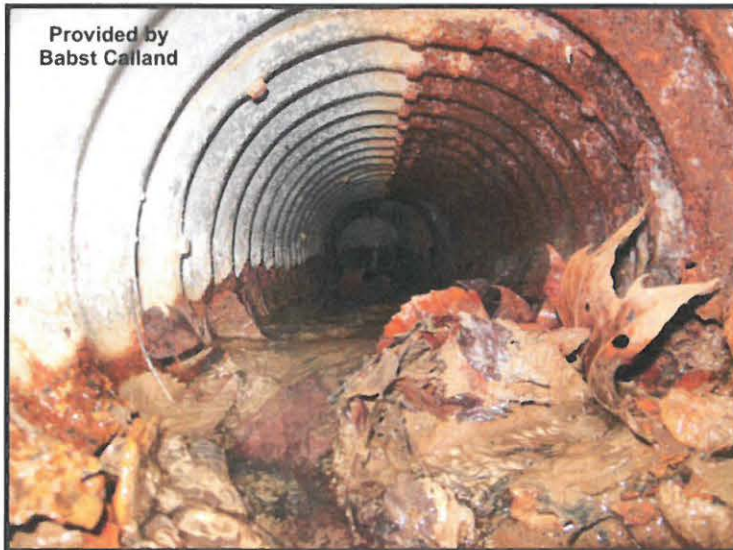
The property had other problems as well. For example, a metal culvert running underneath the tank farm designed to carry stormwater to the river corroded, allowing

water to make its own path or pathways under the facility property. This culvert traveled east to west under the facility in the area just north of tank 395. During the course of the investigation, contractors located, excavated and exposed a section of this culvert. In the area that was exposed, a large void could be seen in the south side of the

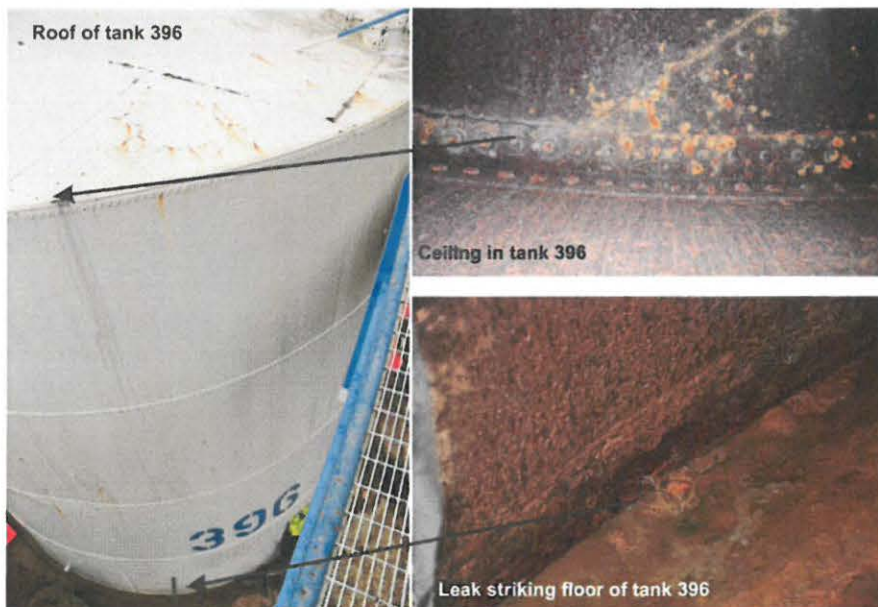
During the course of the investigation, the WVAGO photographed and documented the physical appearance of tank 396 and surrounding tanks. As reflected, in the photographs, the outside of tank 396 had flaking paint, rusting, and pitting. In addition, an inspection of the inside of the tank revealed neglect. First, the roof of the tank was leaking.

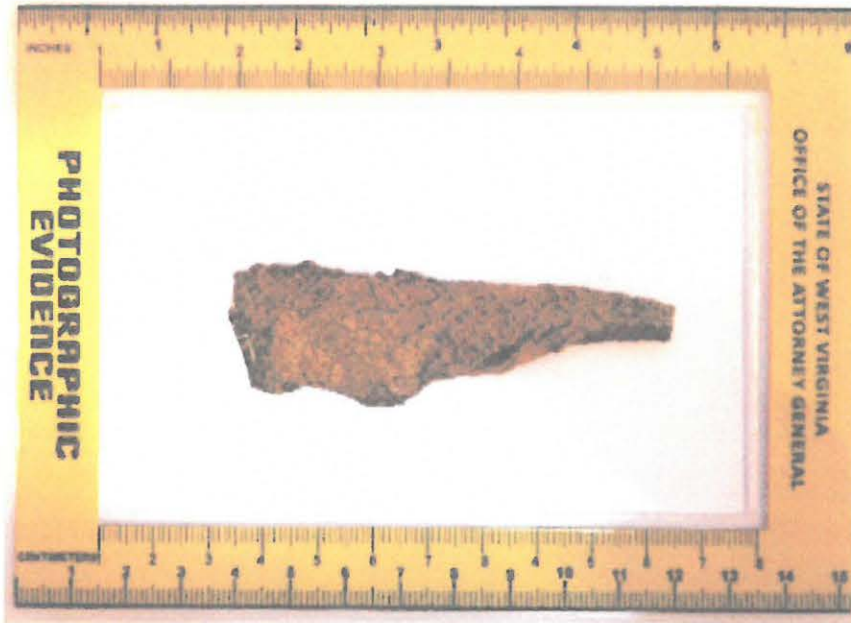
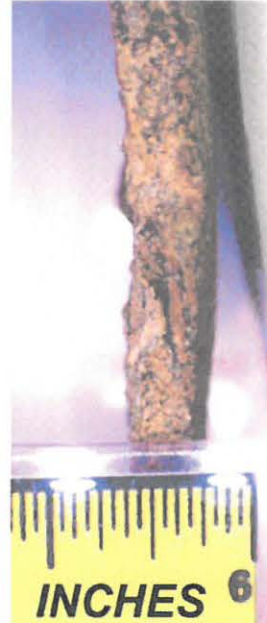
Second, a liner/patch was discovered in the bottom of the tank over the corrosion.

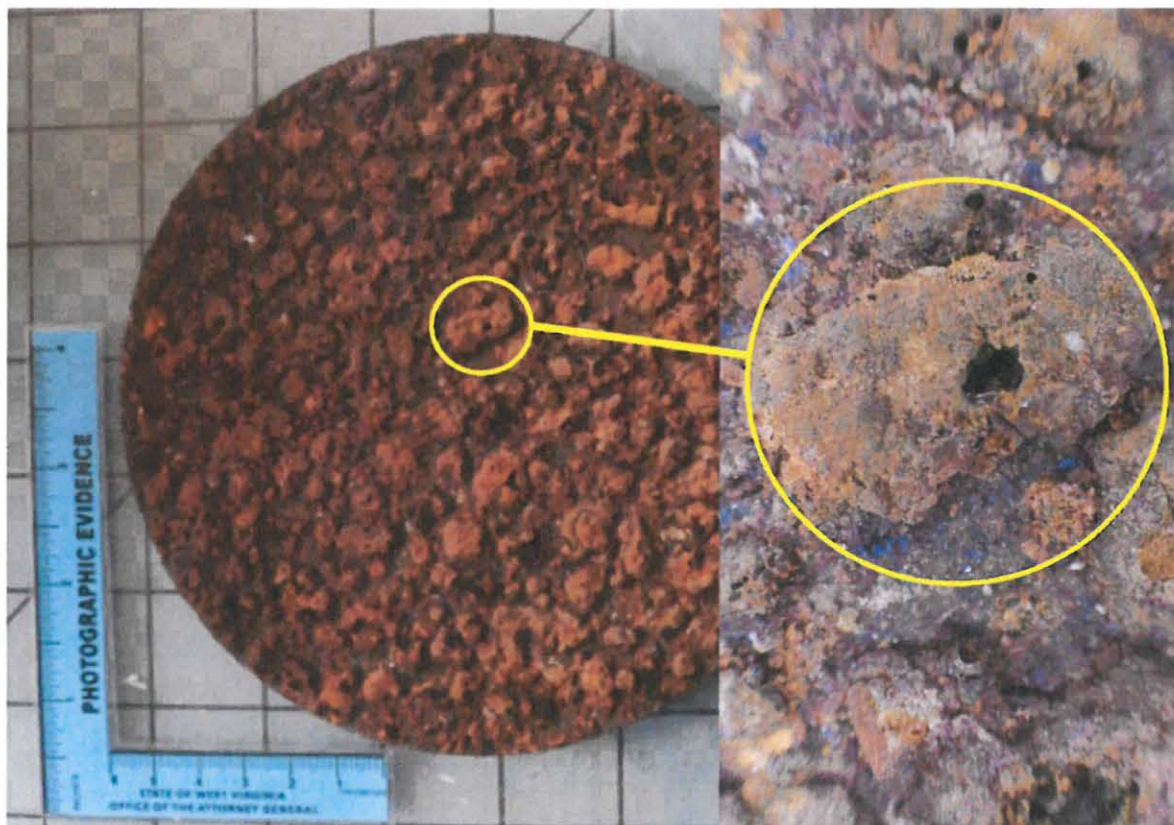
Third, signs of corrosion inside the tank were observed.

Corrosion on inside of coupon removed from side of tank 396

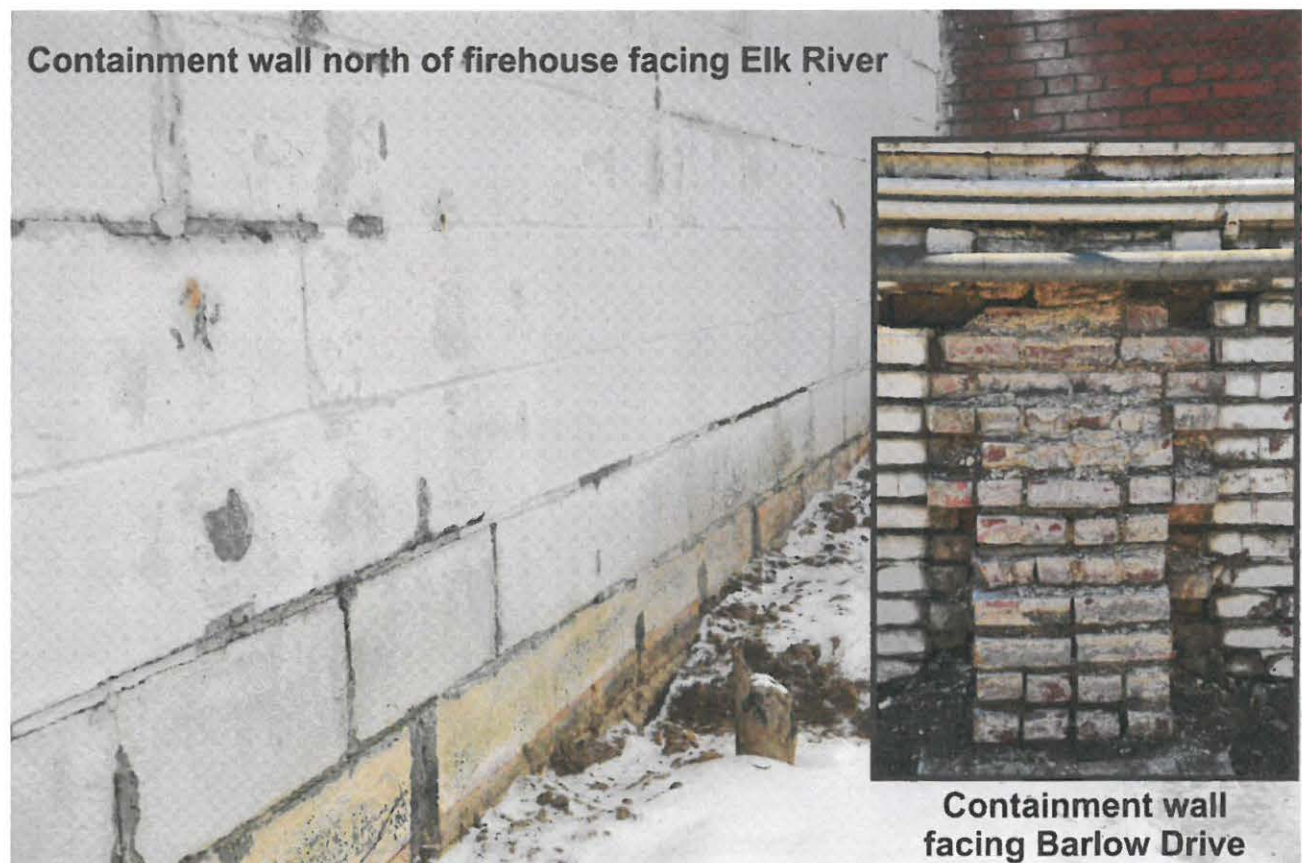
The purpose of the containment (dike) wall was to contain any spill or release of the product from the tanks. The walls, constructed of cinderblocks or bricks, had deteriorated to the point where bricks had broken apart or were completely missing. Cement mortar was missing from between the blocks in several areas.

Containment wall north of firehouse facing Elk River

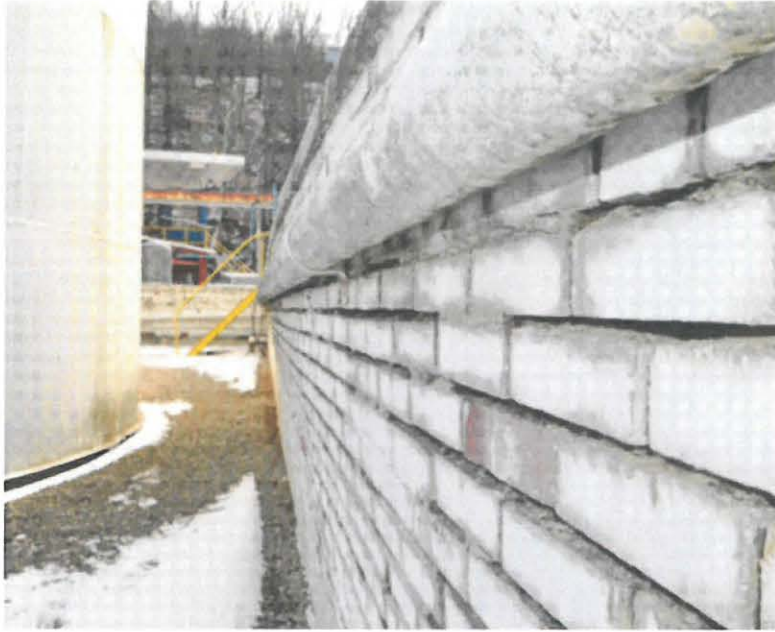
Containment wall facing Barlow Drive

The containment wall running east and west that separated tank 402 from 403 had deteriorated to the point that it was leaning to the north. Concrete caps consisting of either brick and/or cinderblock were used around the top of the containment wall. However, like its structural base, the caps had also deteriorated to the point that some of the mortar

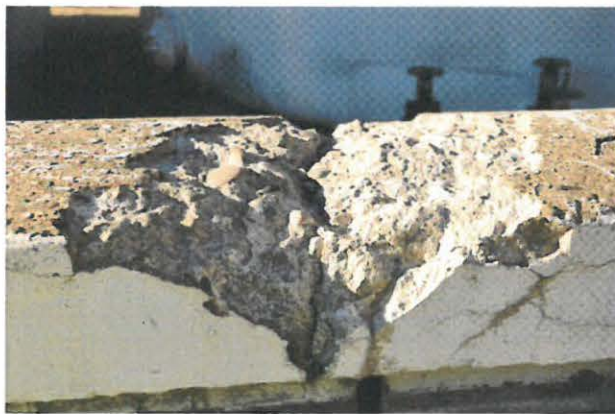
between the blocks and some of the mortar caps were missing. For example, in one section of the west containment wall, a large section of cap was missing, which exposed the open top of the cinderblocks and the hollow center. The deteriorated or missing cap allowed for the infiltration the elements, which further compromised the effectiveness of the dike walls.

Cap of brick containment wall facing Barlow Drive

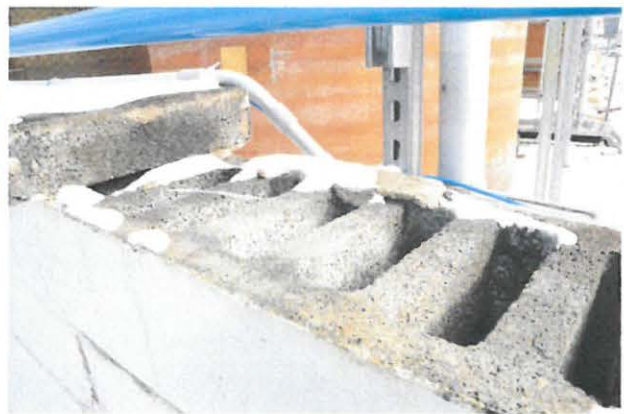
Missing cap on containment wall facing Elk River

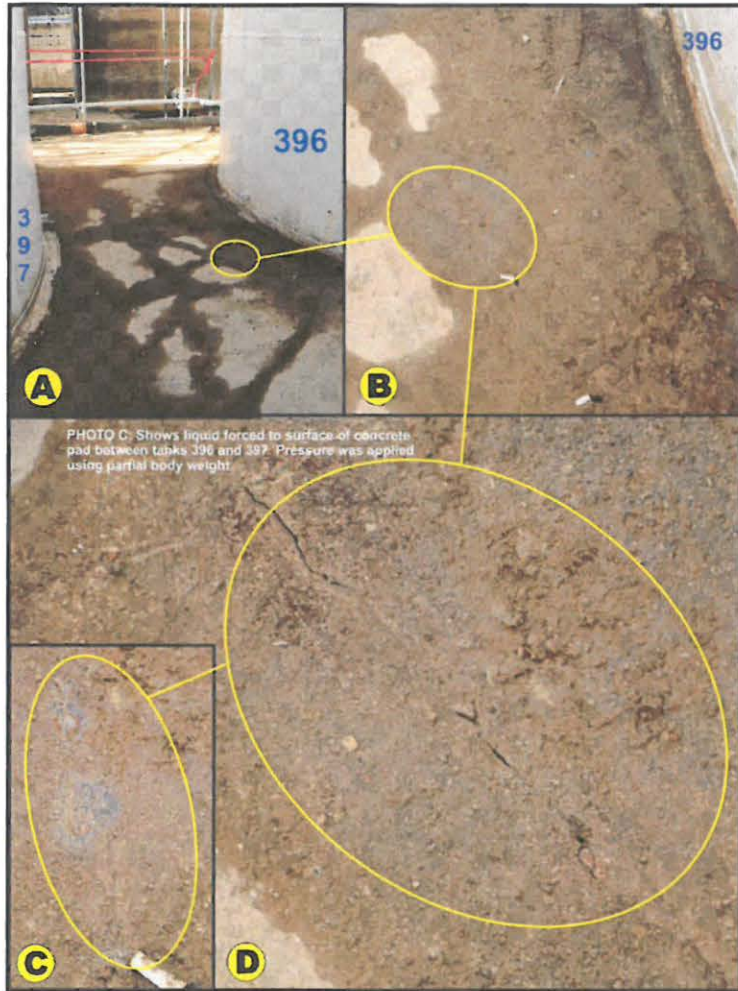
The WVAGO investigators also noted that the concrete pads sloped down toward the chime of the tanks. This slope allowed for the buildup of dirt, mud, and other debris, and for the pooling of water around the chimes of the tanks. The investigation did not determine if the slope of the concrete was a construction defect, or was caused by erosion and/or settlement of the ground beneath the tanks.

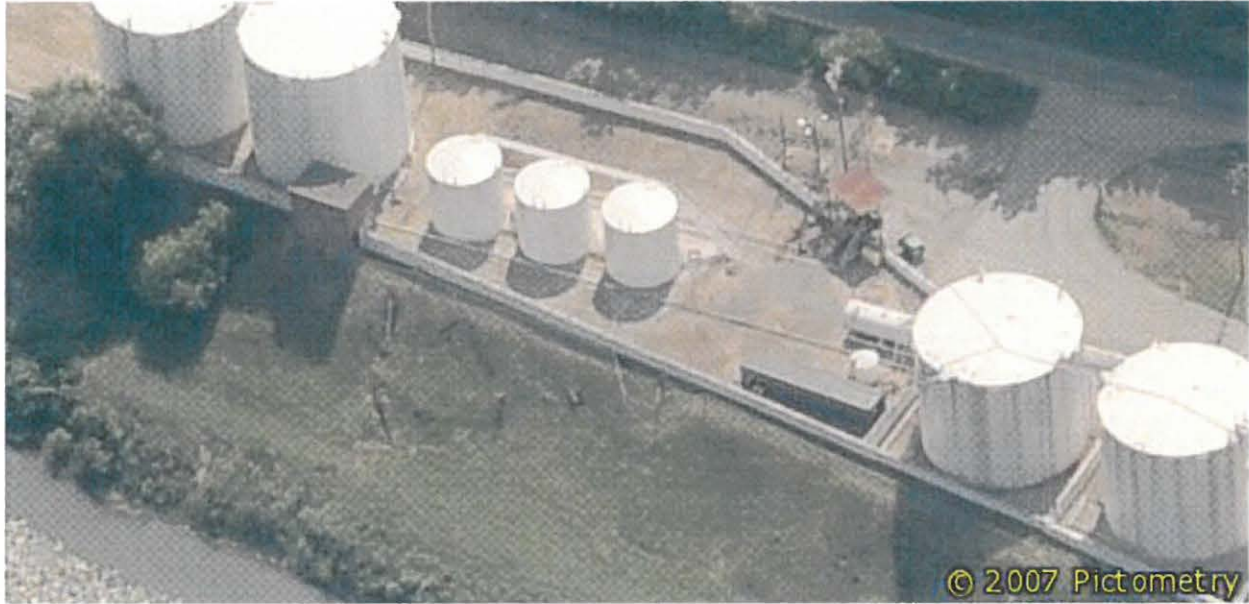
ground erosion on the embankment west of the dike wall near the fire house as the embankment travels towards the Elk River.

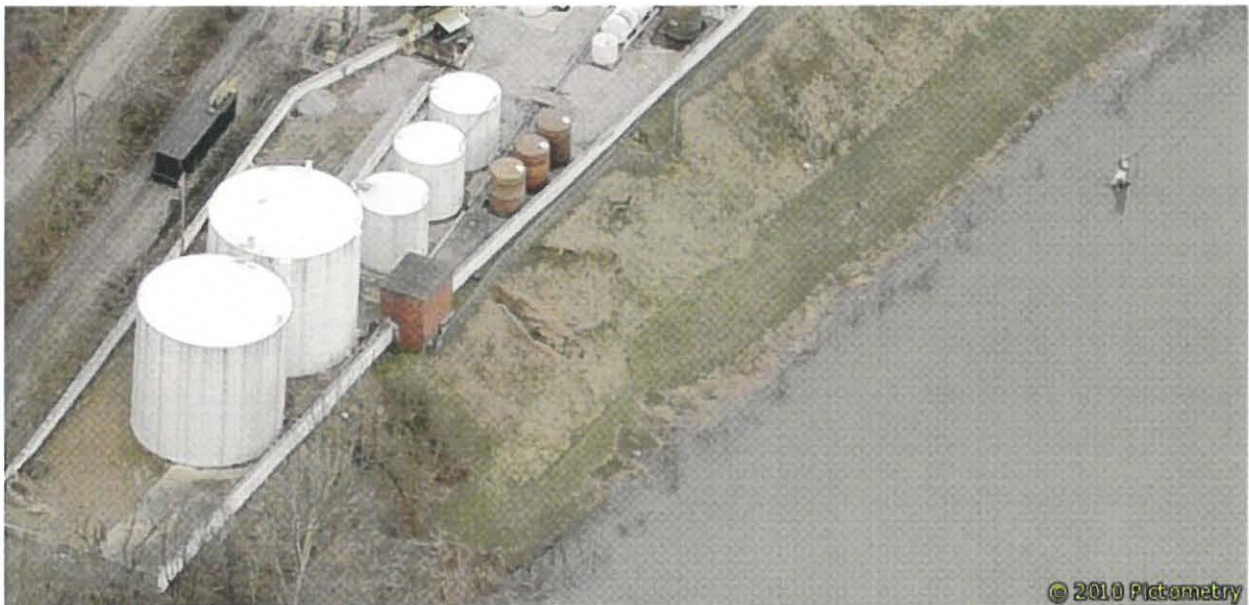
On March 10, 2010, Pictometry International Corporation again prepared aerial images showing the Etowah River Terminal. This image shows that the ground erosion documented on June 12, 2007, had continued and was considerably worse.

Company officials were aware of the erosion as evidenced in four (4) proposals made by Ryan Environmental Inc. on March 23, 2009, to control the river bank erosion.¹⁸ The erosion problem was not corrected and was still present when investigators arrived at the terminal on January 13, 2014.

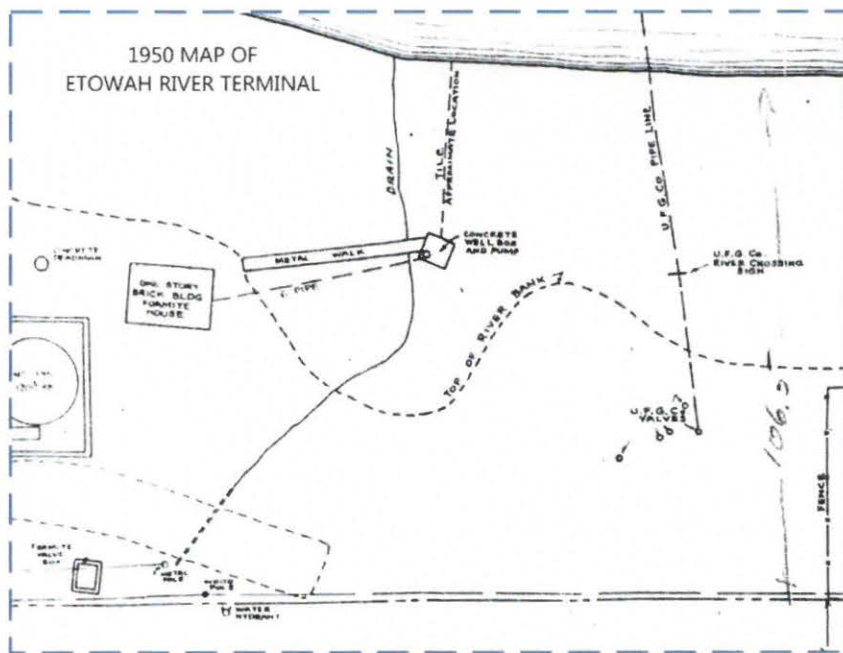
One of the most disturbing findings of this investigation was the fact that tanks 393 and 394 appear to be built partially on fill. A large portion of the ground on which the tanks rest was filled in prior to their installation. This is significant because much of the

product that escaped the confines of the tank ran north due to the slope of the concrete slab to the containment wall in front of tanks 393 and 394. In this area, a significant amount of the product went through and under the containment wall, then flowed into and through the rubble filled bank, and
