Chevron Process Safety Alert

Overpressure of an Explosion-Proof Enclosure

issued: June 2017

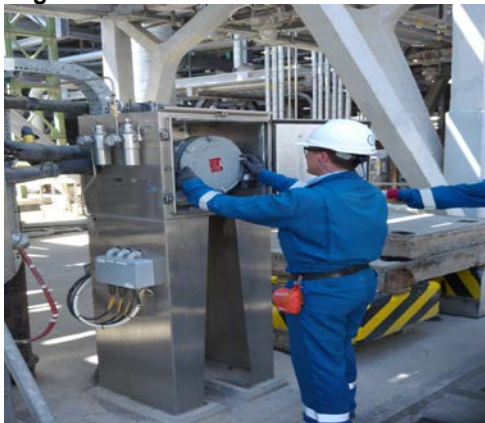
Figure 1: Reenactment of Cover Removal

An analyzer engineer was fatality injured when the engineer removed the cover on an explosion-proof enclosure as part of a routine task. The threaded cover weighing ~12 lbs. and measuring 14 inches in diameter was forcefully propelled from the enclosure as the engineer unscrewed it inflicting a fatal head injury. The force was caused by pressure inside the enclosure from leaking sample gas or instrument air components. The enclosure was not equipped with an external indicator to determine the pressure inside the enclosure and had no means to relieve internal pressure.

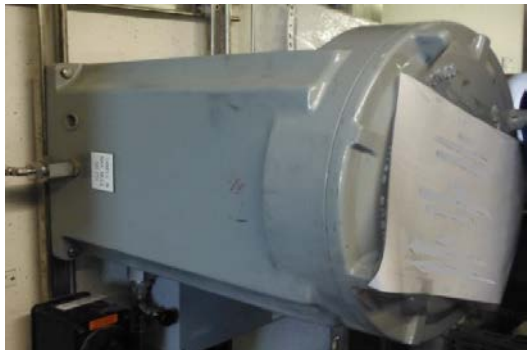
Figure 2: Example of Explosion-Proof Enclosure

- Recognize the potential hazard of trapped pressure in explosion-proof electrical enclosures from all sources of energy entering the enclosure
- Identify explosion proof enclosures which are susceptible to trapped pressure scenarios and do not have pressure indication or pressure relief protection
- Work with equipment manufacturers to develop a mitigation plan that addresses the trapped pressure situation while still maintaining the electrical certification of the identified enclosures
