Office of the West Virginia Attorney General

Elk River Chemical Spill INCIDENT REPORT

January 8, 2015

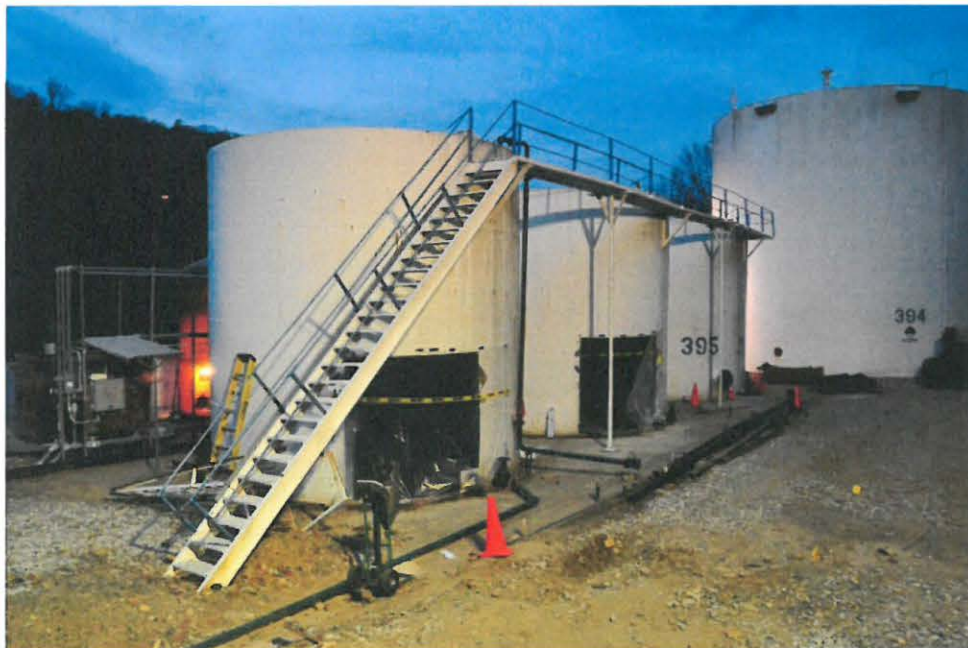
In addition to the containment wall, some of the ASTs were surrounded by concrete pads.

The concrete pads, however, did not extend underneath the ASTs. Instead, there was gravel or rock underneath each AST.

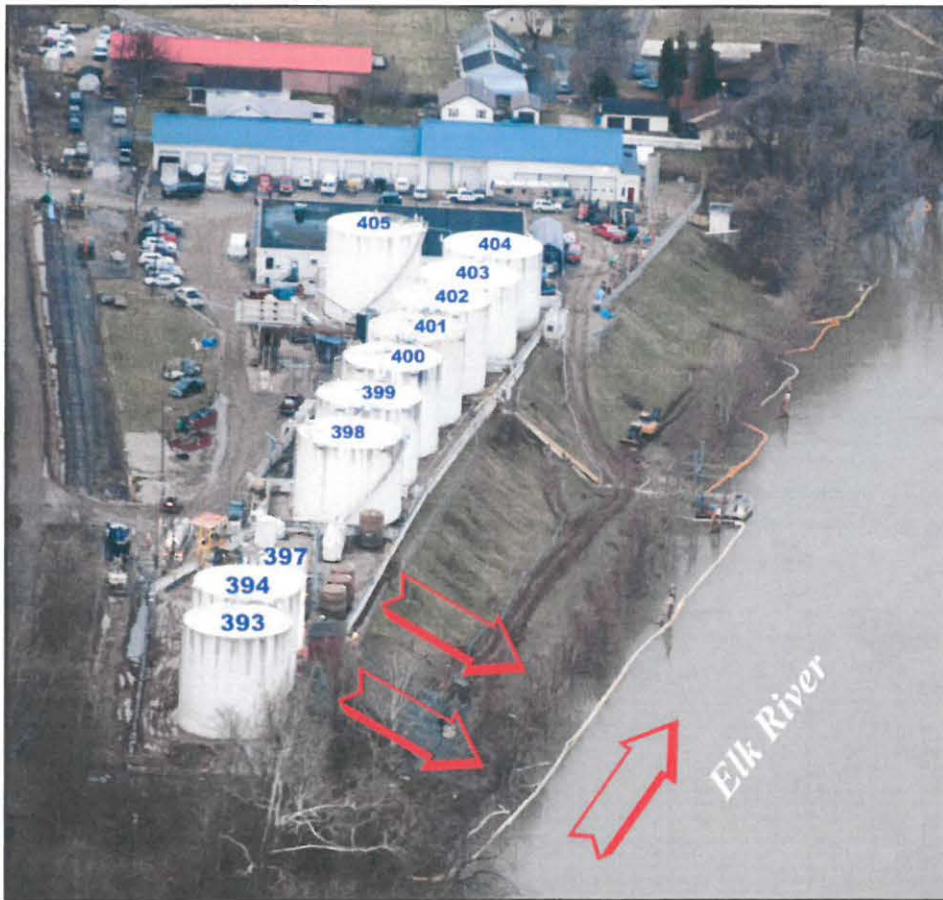
The WVAGO investigation revealed and documented the source of the chemical leak

at Freedom, the path through and under the containment wall, and the subsequent release into the Elk River.

In particular, the investigation revealed that chemicals escaped from tank 396 and tank 397, then flowed northwest to the containment wall in front of tanks 393 and 394.

The chemicals then leaked through and under the containment wall into the rubble-filled ground leading to the Elk River. The chemicals also traveled through a corroded culvert and/or pathways created by water leaking from the culvert. This culvert ran between tanks 395 and 394 and over the embankment to the river. There were thus at least two entry points in which chemicals were able to flow directly into the Elk River. The source and resultant contamination are detailed more fully below.

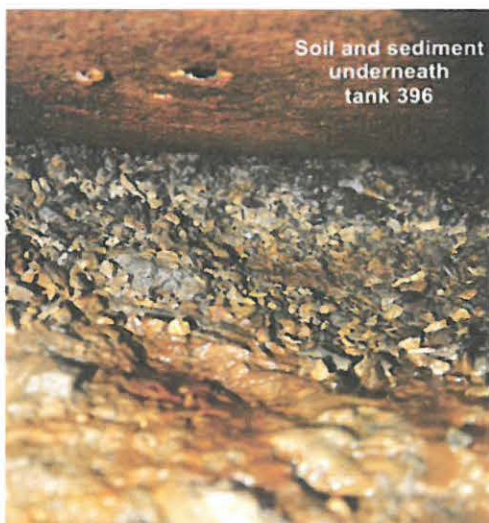
Both tanks 396 and 397 sat above a gravel/soil ground. There was a concrete pad that existed around the base of each tank, but did not extend underneath the tank.

The WVAGO investigation revealed that upon leaking from its respective ASTs, the MCHM chemical product leached into the gravel/soil immediately beneath it. The length of time for the leak is unknown, but based upon observations of corrosion around the holes and tank, the holes existed prior to January 9, 2014.¹³

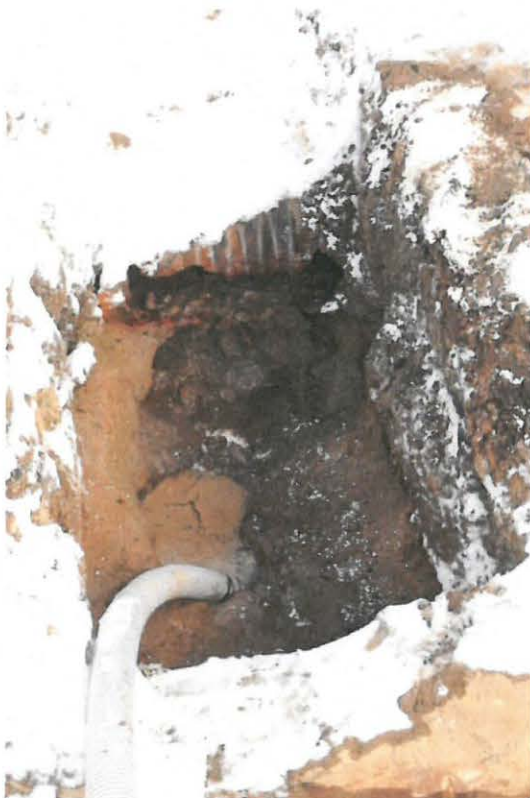
Due to the location of the facility, a considerable amount of water runoff entered the property. The sources include run-off from the airport hill above the facility, storm drainage or a possible natural spring on Barlow Drive, and a deteriorating/eroding culvert.

The run-off from the airport hill was documented by Etowah River Terminal General

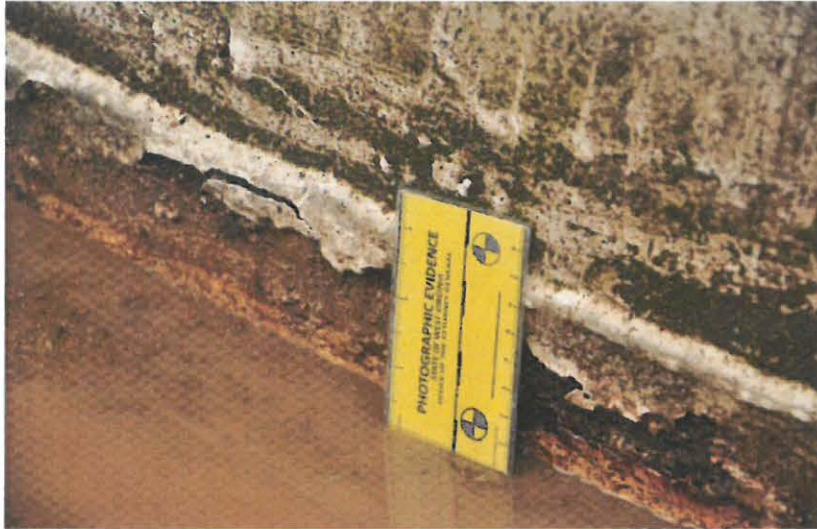
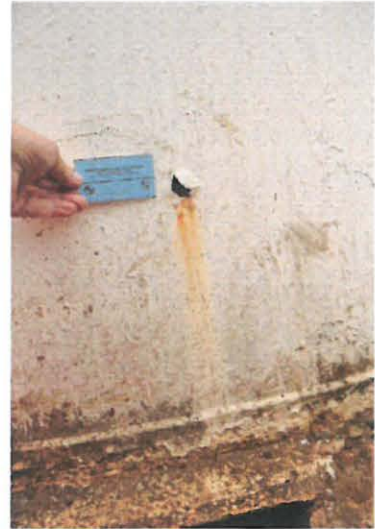
Tank 396 was one of three aboveground storage tanks originally constructed by Elk Refining Company in 1938. A visual inspection of the tank showed its age, and

clearly reflected minimal upkeep of the tank. Despite significant documentation and reports regarding other larger tanks, little documentation or inspection reports were produced by Freedom relating to the maintenance or inspections of tank 396.

During the course of the investigation, the WVAGO photographed and documented the physical appearance of tank 396 and surrounding tanks. As reflected, in the photographs, the outside of tank 396 had flaking paint, rusting, and pitting. In addition, an inspection of the inside of the tank revealed neglect. First, the roof of the tank was leaking.
